# Manhole Inspection Summary

Manhole # S31E\_\_005MH

Insp Date: **8/5/08 11:26 AM**

**Location** Address: **rear 308 e fayette st**

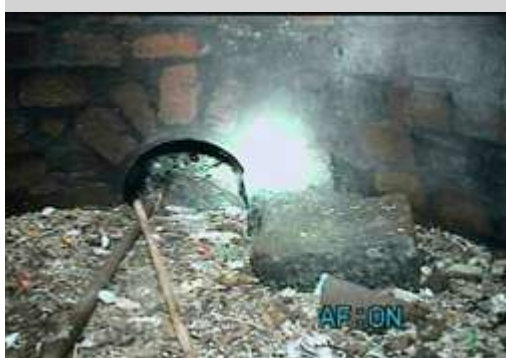
Defect 2

Condition: ☐ Sound ☐ Cracked ☐ Root Intrusion ☐ Deteriorated ☐ Leaks ☒ **Debris**

channel debris

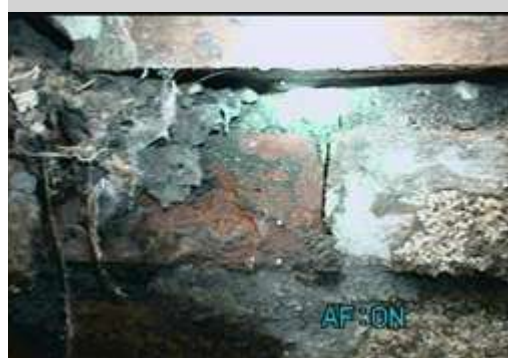
Defect 1

Condition: ☐ Sound ☒ **Cracked** ☐ Root Intrusion ☒ **Loose Brick** ☒ **Deteriorated**

chimney cond deteriorated with cracked, loose bricks

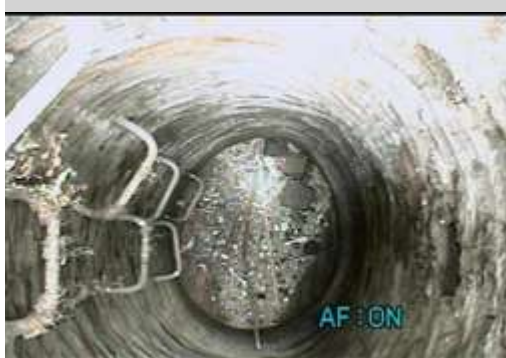
Defect 3

Count: **7** Missing: **0** ☒ **Corroded**

corroded steps

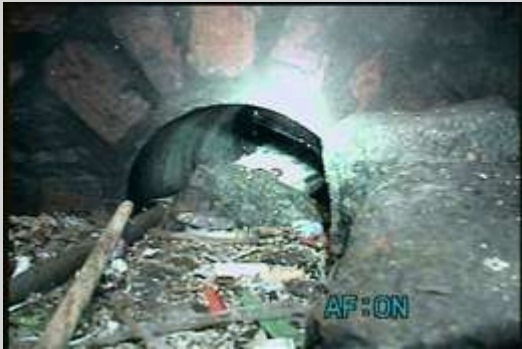
12 O'Clock Outflow

Deposits: ☐ None ☐ Mud ☐ Sludge ☒ **Debris** ☐ Grease

Silt Depth: **3** (in.) Deposits Extent: **Medium**
